Roof Assessment and Proposed Solution

O-I - Lavington, BC

Prepared On: 05/12/2011

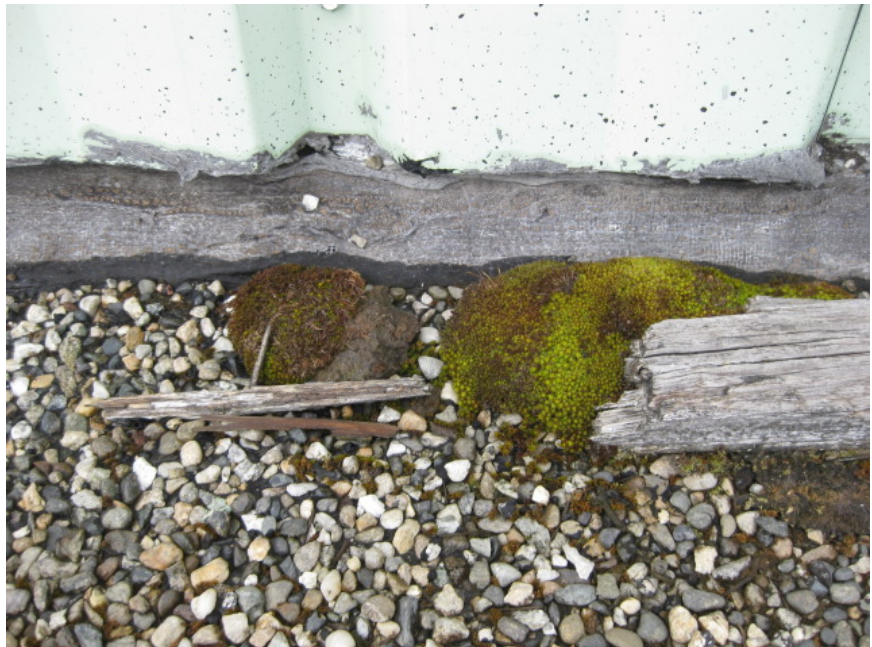
Section: B (BUR)

Caption: (All) Wall Flashing Failure

Accessories-(All) Wall Flashing Failure

Flashing is failing due to ultra violet exposure, building movement and expansion and contraction of building components.

Failing flashings allow moisture into the roof system. Moisture in the roof accelerates the failure of the roof system, insulation and decking.

- (All) Wall Flashing Failure - Allows moisture that results in premature membrane, insulation and decking deterioration. (see photo)

Flashing needs to be restored to ensure a watertight condition.

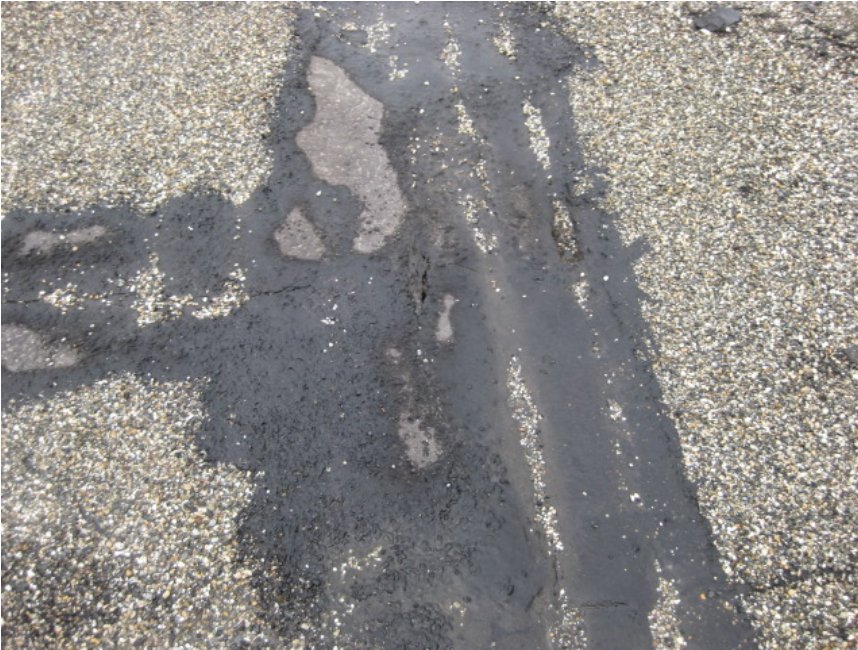
Section: A (BUR)

Caption: (All) Punctures / Tears - Abuse

Field of the roof-(All) Punctures / Tears - Abuse

The most common reason for punctures and tears is abuse of the roof.

This condition can allow moisture entry into the building and roof system, causing damage to the building contents, and deterioration of the insulation, decking and the roof system.

- (All) Punctures / Tears - Abuse - Allow moisture to enter the roof system leading to premature roof failure. (see photo)

Repair membrane as needed.

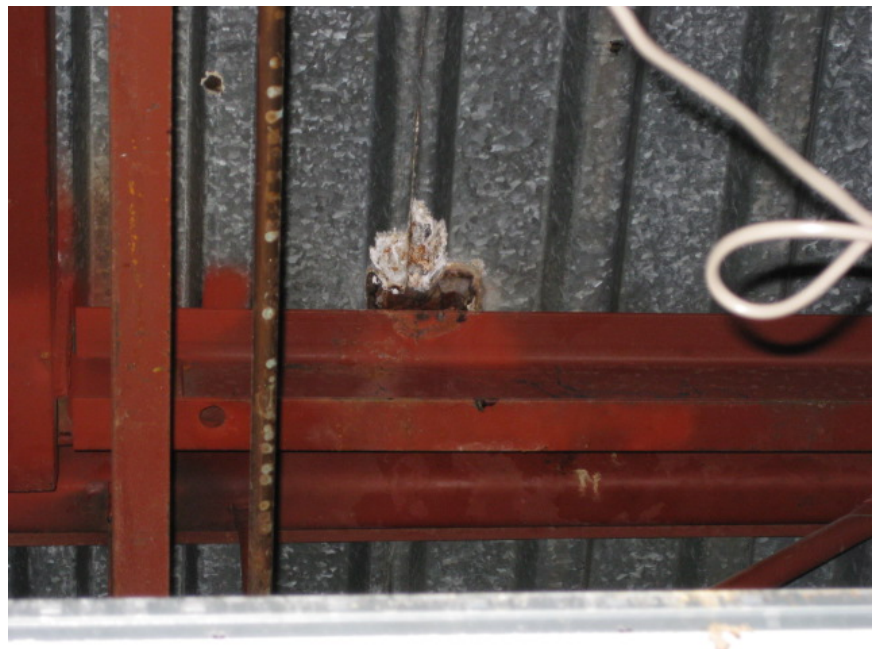
Section: D

Caption: (All) Oxidation / Rust - Voids or Holes

Deck-(All) Oxidation / Rust - Voids or Holes

Deck is rusted/oxidized through due to prolonged exposure to moisture or other corrosive conditions.

This is a serious safety concern. The structural integrity of the decking has been compromised. Any roof top traffic should be prohibitive in this area to prevent serious injury. Furthermore, caution should be given to activities below this area.

- (All) Oxidation / Rust - Voids or Holes - Rust/oxidation has create safety concerns with the structural integrity of the metal deck. (see photo)

Remove and replace the existing wet roofing materials and deck.

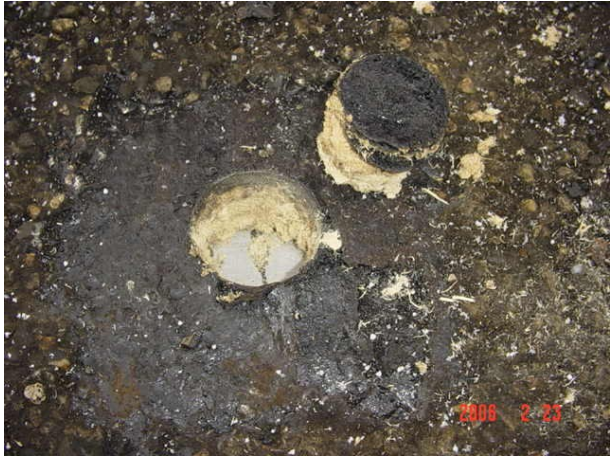
| Section: A (BUR) | Sq. Footage: 70,644 | Leaks: | | | | | | | | | | | | | | | | | | |
|---|---|---|---|--|--|---|---|---|---|---|---|---|---|---|---|---|---|---|---|---|
|

Membrane: The field of the roof has clearly reached the end of its life cycle. Previous repairs have been made and further attempts to repair this roof are not recommended.

Insulation: The insulation has become saturated in identified areas. This moisture-laden material needs to be removed and replaced immediately to prevent further costly deterioration.

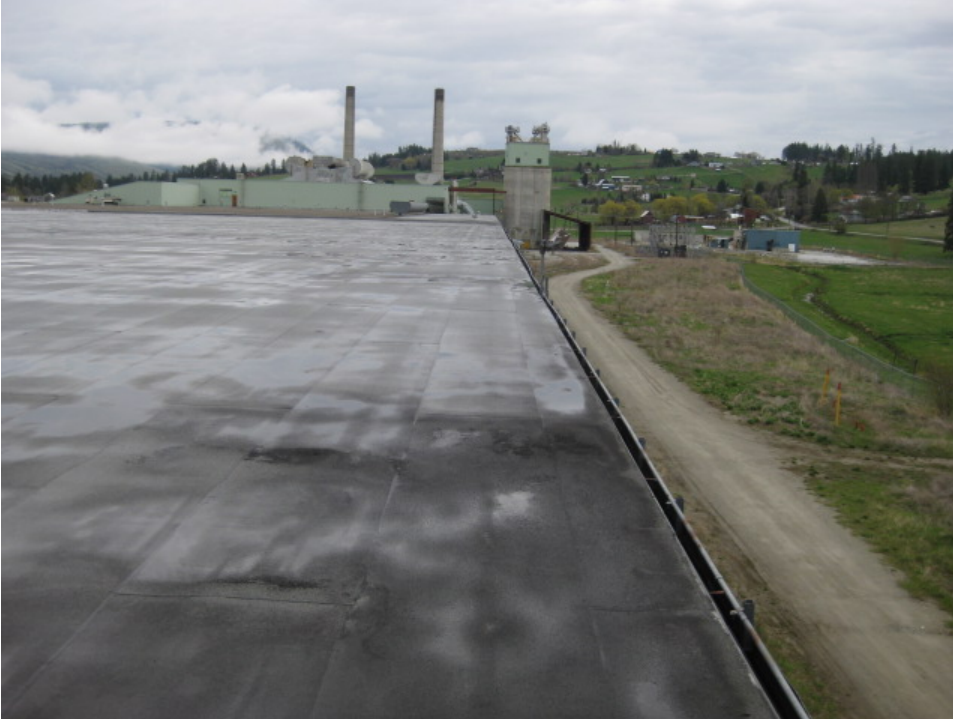
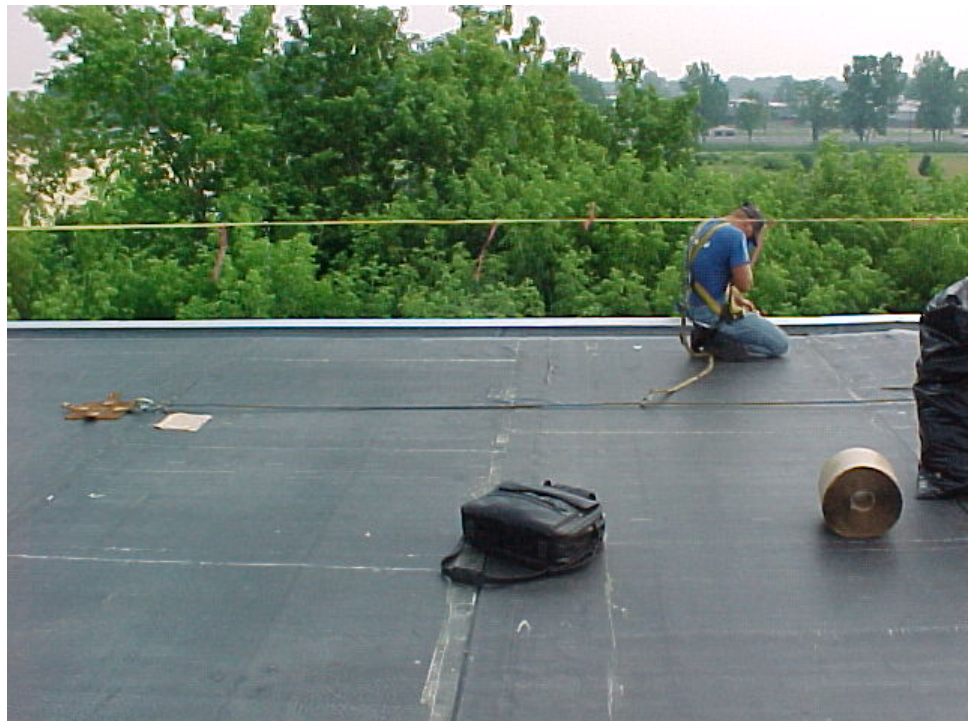
Section: A(SBS)

Exposed Edges - Fall Hazard

Run a 3/8 inch cable, 7ft back from edge, to prevent employee, wearing a 6ft lanyard, from reaching the fall hazard but still allowing work to be done on the edge.
